# Incidental Detection of a Femoral Neck Fracture Through Visual Analysis of a Dual-Energy X-ray Absorptiometry Scan Image

Han-Kyung Seo, Radiological Technologist\*

Department of Nuclear Medicine, Jeonbuk National University Hospital, Jeonju, Korea

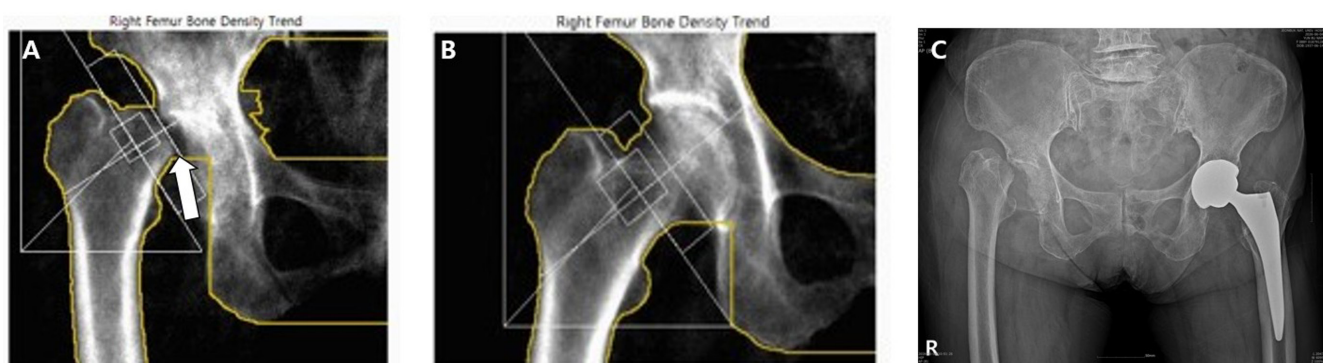
**Fig. 1.** The patient in this case was an 88-year-old woman with a history of left total hip arthroplasty. She presented with right buttock and thigh pain accompanied by marked swelling. However, the clinician initially attributed her symptoms to lumbar spine disease and ordered lumbar radiography and Dual-Energy X-ray Absorptiometry (DXA) examination without direct radiographic evaluation of the hip. To avoid measurement artifacts caused by the left hip prosthesis, a DXA scan of the right proximal femur was performed (A). During real-time image acquisition, the attending radiologic technologist carefully reviewed the scan image and identified a distinct fracture line in the right femoral neck (A, arrow). Comparison with a previous DXA examination (B) performed in 2019 confirmed the absence of any fracture findings at that time, indicating that the lesion was newly developed. After identifying the right femoral neck fracture on the DXA scan image, the orthopedic team promptly informed a hip specialist, and the patient was admitted for surgical treatment. Subsequently, an anteroposterior pelvis radiograph (Pelvis AP) was obtained, which clearly confirmed the presence of the right femoral neck fracture (C).

The patient in this case was an 88-year-old woman with a history of left total hip arthroplasty who presented with right buttock and thigh pain accompanied by marked swelling. The clinician initially attributed her symptoms to lumbar spine disease and ordered lumbar radiography and a Dual-Energy X-ray Absorptiometry (DXA) examination (GE, Lunar iDXA, USA) without direct radiographic evaluation of the hip. During the examination, the attending radiologic technologist identified findings suggestive of a right femoral neck fracture on the DXA image of the right femur and confirmed that it represented a newly developed lesion through comparison with a previous DXA study. The patient was subsequently evaluated by the orthopedic team, and additional imaging studies confirmed the right femoral neck fracture. She was then admitted for surgical treatment.

Recognizing the clinical significance of this finding, the radiologic technologist immediately documented the abnormality through the Picture Archiving and Communication System and directly notified the orthopedic team. This prompt communication facilitated further evaluation and timely management of the patient.
